LANDSLIDE PROTECTION OF ROADWAY NETWORK DURING THE CONSTRUCTION AND RECONSTRUCTION

Abstract. The article discusses an example of construction and operation of a high embankment of the road, which was constructed in the central part of Moldova. A detailed historic reference about the behavior of the embankment over 40 years of its operation is given. The reasons for the repeated deformations of the embankment have been identified. The analysis of the effectiveness of the undertaken landslide prevention works has been performed. In order to increase the effectiveness of landslide protection, the authors propose a procedure for multifactorial analysis of the interaction of complex natural systems and various engineering structures, which will allow designers to reasonably predict and make accurate design decisions in diverse geological settings.

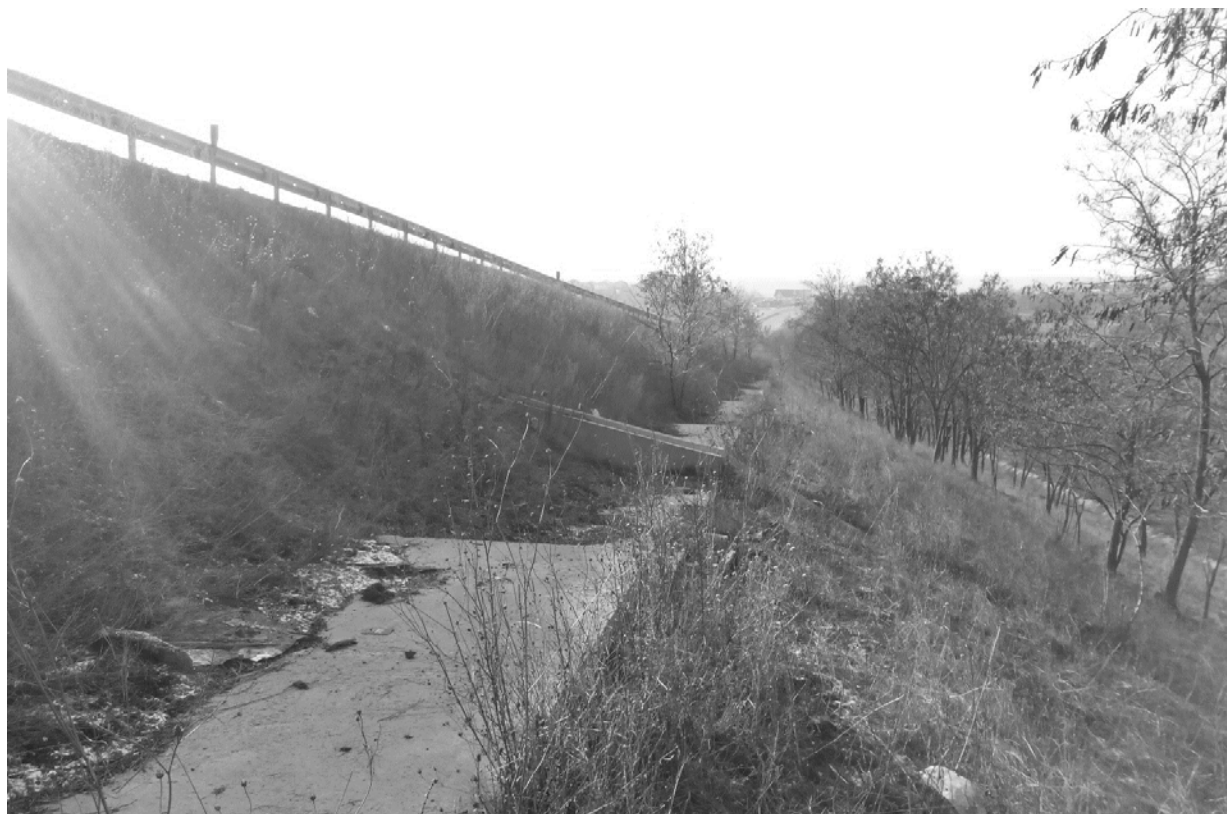
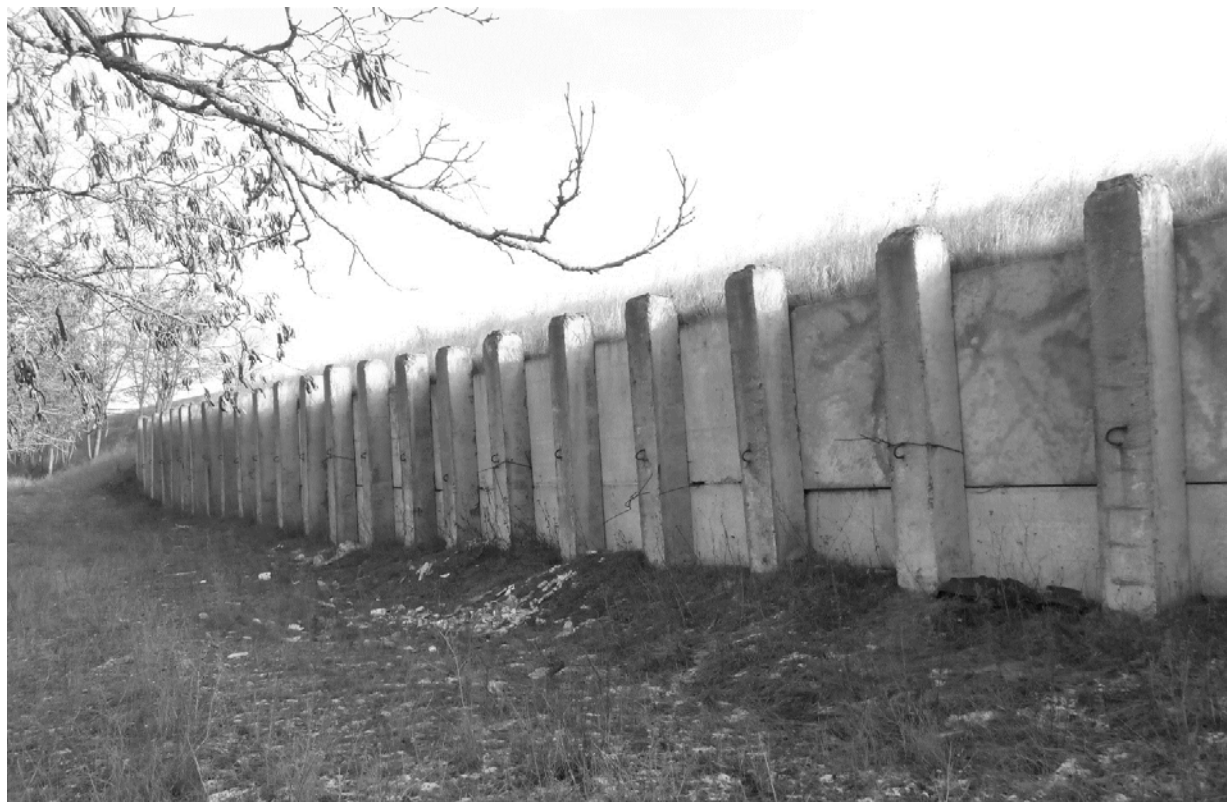
Figure 3. Section of embankment in December of 2019.
Source: Rascovoi A. from Technical University of Moldova.

Figure 4. Section of embankment in December of 2019.
Source: Rascovoi A. from Technical University of Moldova.

In December of 2019, the authors of this work carried out a visual inspection of the embankment section and performed works. It showed that there are no significant deformations in the mass of the embankment. However, in some spots, in the surfacing, there are longitudinal and transversal cracks opening up to 2 cm wide (Figure 5, 6). The origin of the cracks can be explained by the unfinished consolidation of the newly filled soils and, presumably, by the insufficient rigidity of the road material.
