To cite this article: D C Albu and A Lesan 2021 *IOP Conf. Ser.: Mater. Sci. Eng.* **1209** 012008

Opportunities for rehabilitation of facades of historic buildings in Moldova with limestone elements

D C Albu¹ and A Lesan²

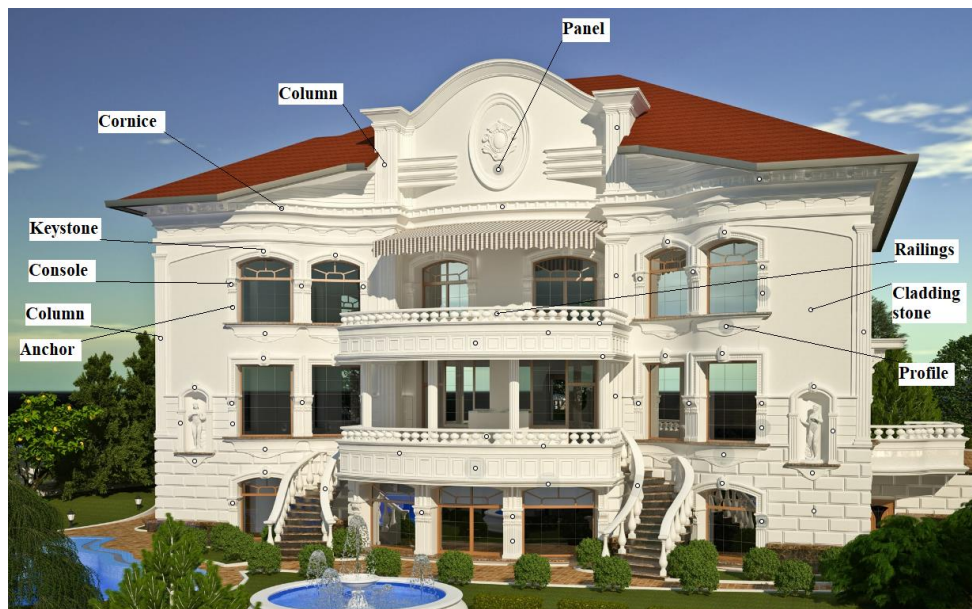
Figure 1. Limestone elements for façade.

Figure 1 shows the basic limestone elements of a facade, which can be custom-made depending on the architectural style of the historical building.

From an architectural point of view, various elements shown in Figure 1 can be rehabilitated using limestone.

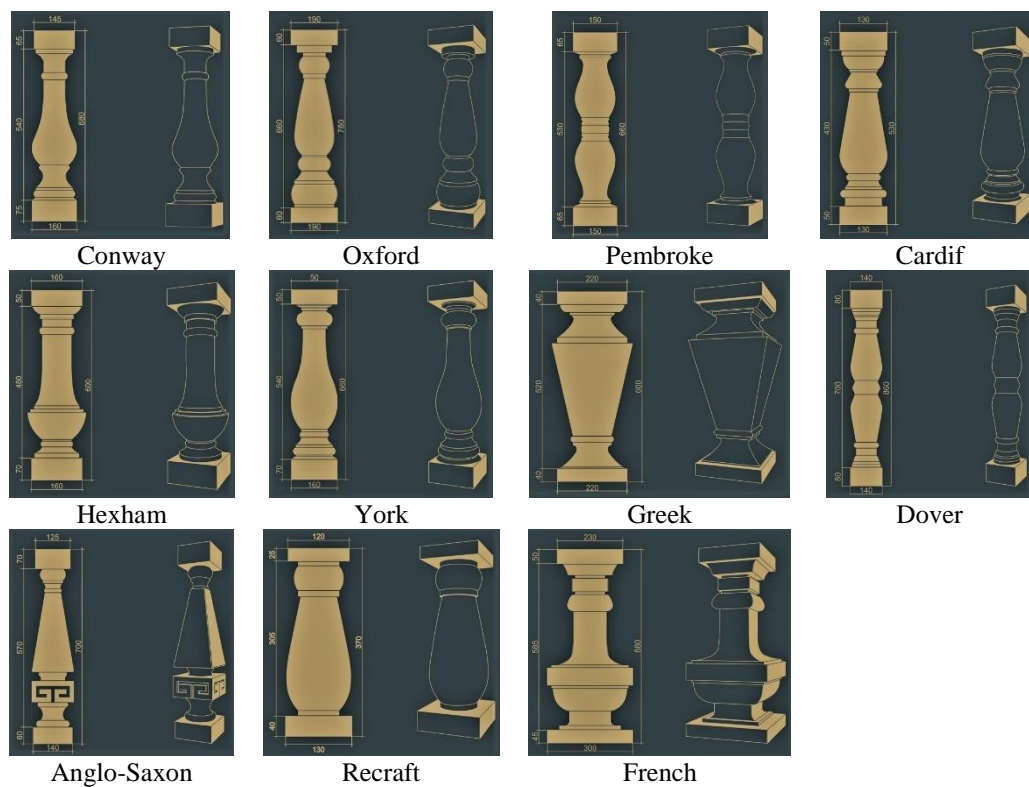
Figure 3 shows the types of railings that can be made from limestone.

Figure 3. Types of natural stone railings.

The shape of the railings, its size and other parameters are determined individually for each case. The limestone balusters have the following advantages:

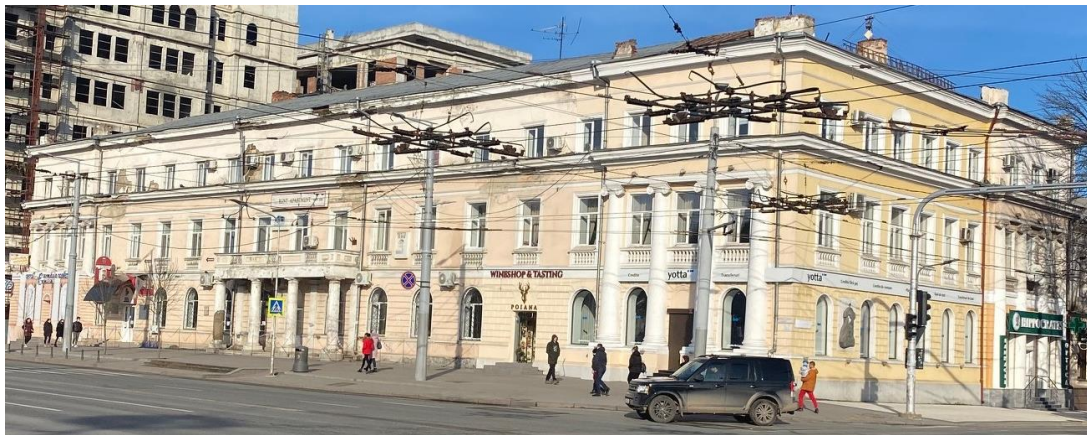
The building has undergone a number of restorations over the years, the last restoration being of the clean-up type. At present the condition of the facade is in a less than satisfactory state, shown in Figure 5. For the restoration of the façade, the method of restoration by reconstruction should be used, with architectural elements made of natural stone, namely limestone.

Figure 5. Facade of the historical monument on 148 Stefan cel Mare Boulevard, Chisinau, Republic of Moldova, 2021.

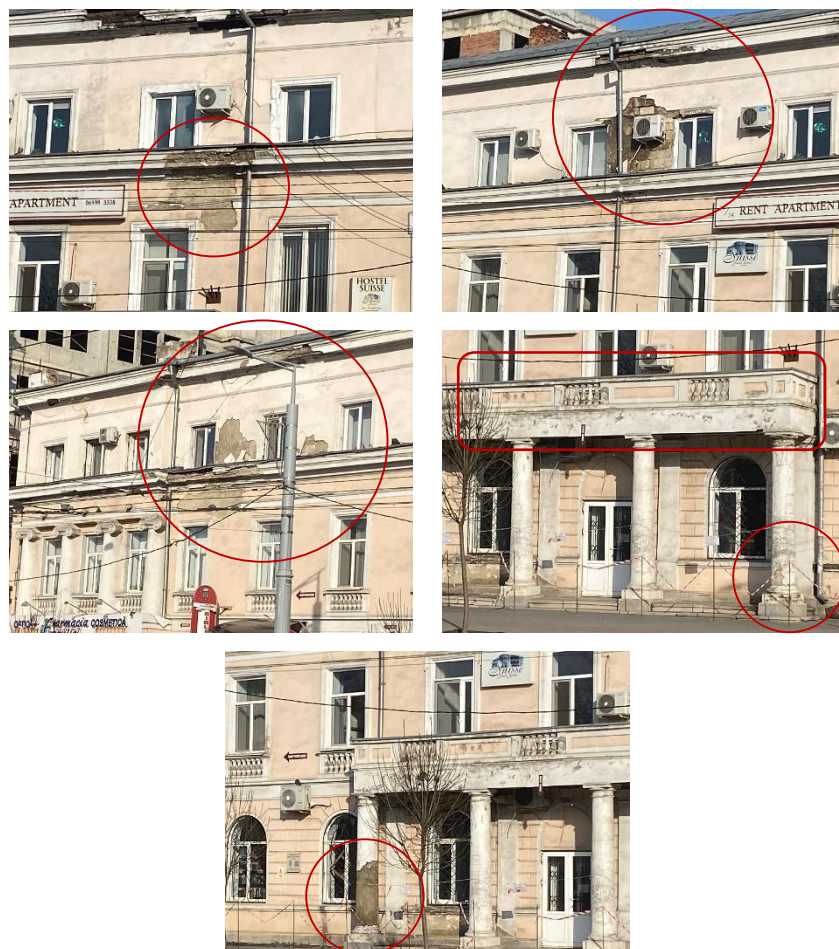
Before starting the restoration and proposing effective solutions, an on-site inspection of the facade was carried out and is shown in Figure 6.

Figure 6. Inspected facade of the historical monument at 148 Stefan cel Mare Boulevard, Chisinau, Republic of Moldova, 2021.

1. Removal of old plaster;
2. Removal of destroyed items such as:
 - a. Cornice;
 - b. Railings;
 - c. Console;
 - d. Anchor;
 - e. Columns.
3. Prime the walls;
4. Apply plaster over the mesh;
5. Priming walls over plaster;
6. Mounting the decorative limestone elements using adhesive.
